## PRELIMINARY EIFS EVALUATION REPORT

Client:	W	Project No.:	3909-179
Project Address:	6208 Amberly Circle	Date:	06-08-07
	Suffolk, Va.	Inspector:	Robert Santana
Mailing Address:	Same as above	Structure Type:	Single Family
		No. of Floors:	1
Phone:	757-000-0000	Ext. Sys. Type(s):	EIFS Drainage System
Email:	<a href="mailto:KariPriller@yahoo.com">KariPriller@yahoo.com</a>	Approx. Age:	11 Years
Approx. Size:	Under 1,000 sq. ft of EIFS	Ordered By:	Kari Priller / Century 21/Nachman
Repairs/Leakage Reported:	None

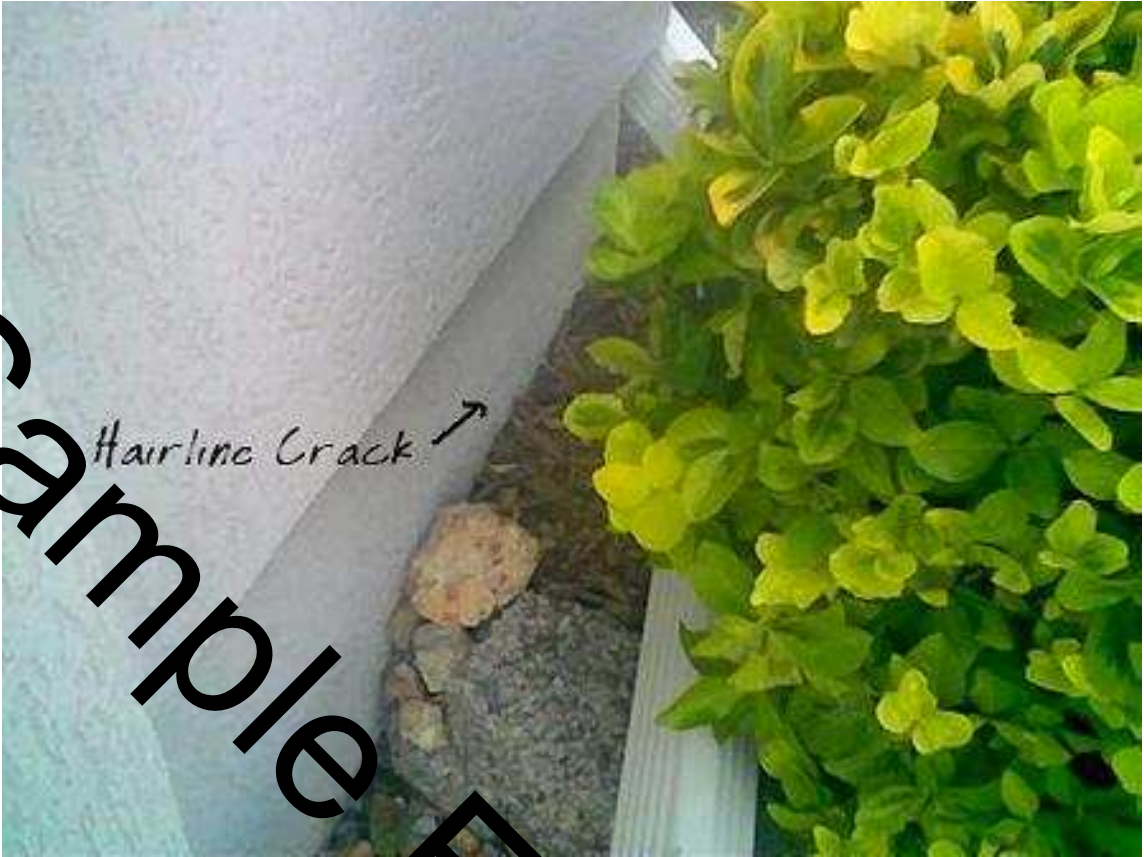
1. Small hairline cracks observed at garage foundation.
2. Very small impact damage right side of garage wall. (1/4")
3. Inadequate caulk joint at EIFS terminations.
4. Bad patch job is evident at the front door and window.

Hairline Crack →

- Hairline cracks should be repaired immediately to avoid further spreading which can lead to delamination of the finish coat.
- Small impact damage should be repaired to prevent moisture intrusion as well as to prevent premature erosion of the EIFS.
- EIFS terminations should have at least a 3/8" joint. This home is a one story structure so the settlement damage due to joint spacing is low.
- All EIFS terminations need to be sealed.
- The previous patch did not match existing color. I recommend painting with an elastomeric coating.

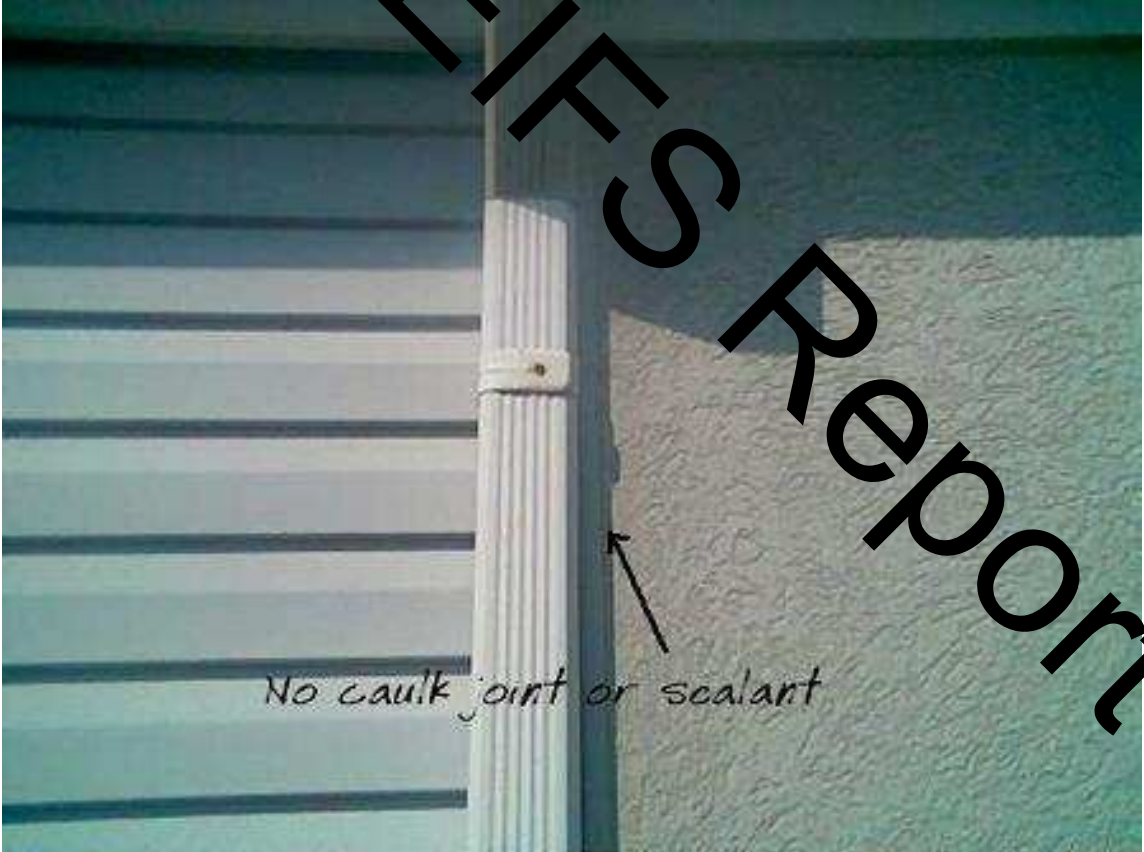
No caulk joint or sealant →
